The Albion-Sheridan Landfill PRP Group

Subject: Final Construction Inspection, Albion-Sheridan Township Landfill

**FINAL INSPECTION
ALBION-SHERIDAN TOWNSHIP LANDFILL
NOVEMBER 2, 1999
ALBION, MICHIGAN**

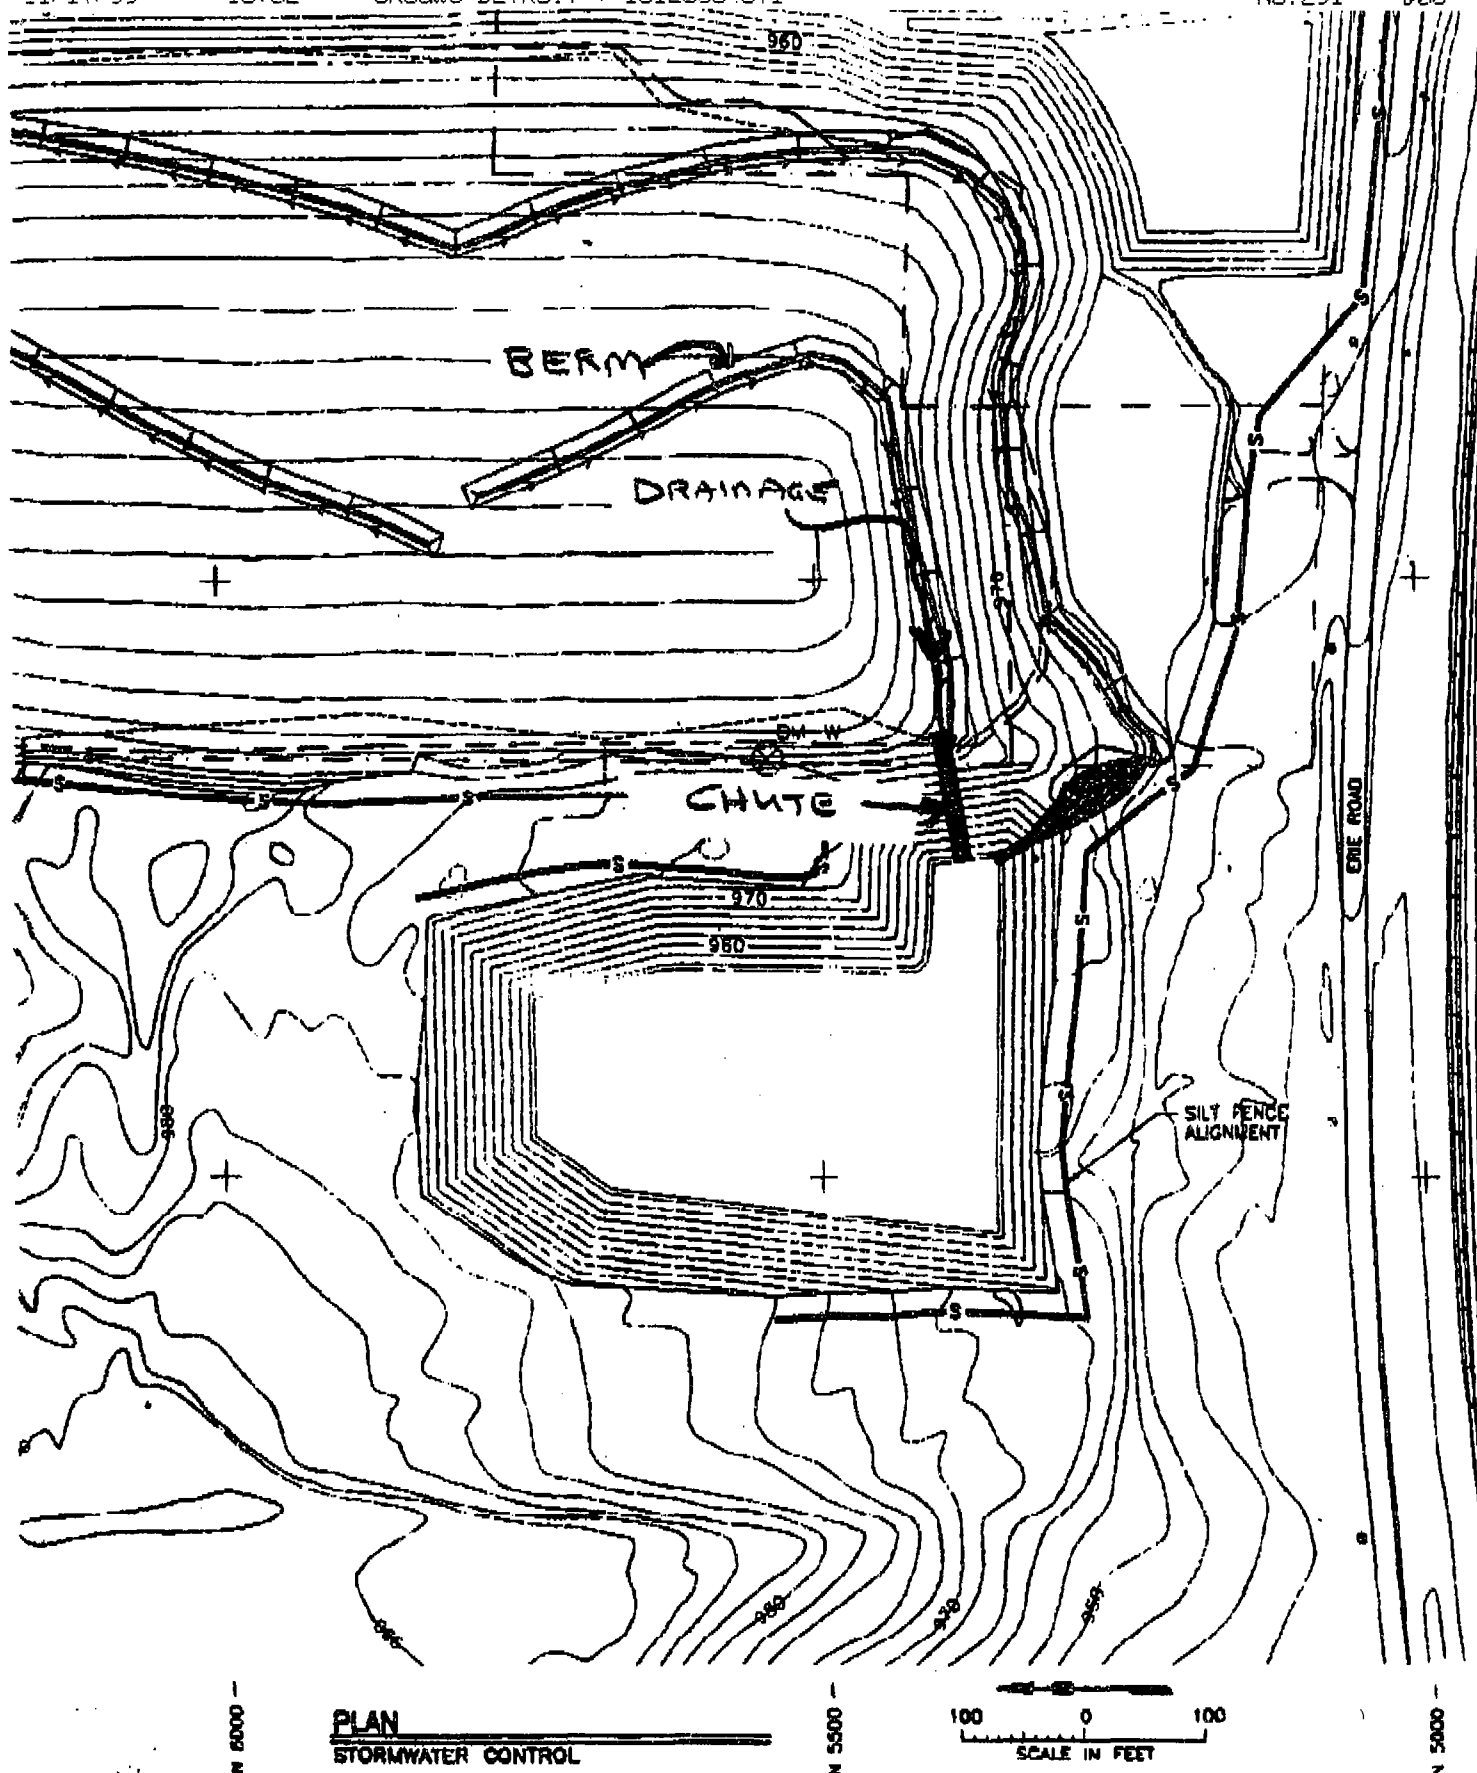
From:
Drawing 10 of
10

11. The rip rap chute in the southwest corner of the landfill appeared to not convey the water from the slopes. In accordance with the design, the chute is designed to convey the surface water only from the southern berm located on top of the landfill (see attached sketch). Based upon the observations of the Resident Engineer during a rainfall event, the chute received water from the southern berm and performed as designed. The surrounding land surface areas are designed to drain surface water runoff as sheet flow into the west drainage retention basin.
